## Case Report

# Characterization of Fungal Colonization of Indwelling Esophagostomy Tubes

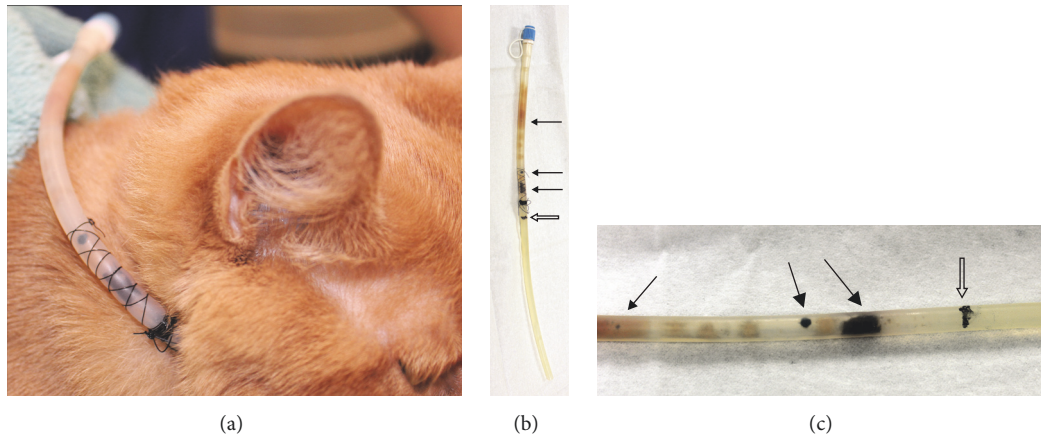
FIGURE 1: A silicon esophagostomy tube exposed for 77 days in a cat (case 1). (a) The esophagostomy tube prior to removal. Note the multifocal darkly pigmented plaques, primarily within the area of the suture finger trap at the site of tube insertion. (b) The esophagostomy tube after removal. Solid black arrows highlight darkly pigmented plaques, while thinner, lighter colored plaques extend up the insertion tube. The hollow arrow indicates a marker line at the site of interface of the tube and stoma. Note the lack of plaques below the interface line. (c) Close-up photo of the esophagostomy tube after removal of the suture finger trap. Solid black arrows highlight the most prominent plaques. The hollow arrow indicates a marker line at the site of insertion into the stoma.

**2.1. Case 1.** A 2-year female spayed domestic shorthair undergoing treatment for severe chronic rhinitis and bacterial pneumonia had a silicone E-tube (Jorgensen Laboratories, Inc., Loveland, CO) exchanged because of darkly pigmented growth on the tube's luminal surface of 3-4 day duration (Figures 1(a)-1(c)). At the time of the exchange, the cat had an E-tube in place for a total of 154 days, with the most recent tube exchange being 77 days earlier because of accidental dislodgement.

Multifocal dense, brown, pigmented growth was visible near the site of tube insertion into the body. The growth would not scrape off the surface of the tube, so the superficial layer of the tube was scraped to collect a sample for culture and identification. Multicell macroconidia of a melanin producing filamentous fungus were identified with light microscopy. *Curvularia* sp. was identified on fungal culture. Scanning electron microscopy findings included a thick biofilm with matts of fungal mycelia and curved macroconidia characteristic of *Curvularia* spp. The biofilm was too dense to allow evaluation of the underlying tube surface (Figures 2(a) and 2(b)).

Once sufficient wire was advanced to avoid risk of accidental dislodgement, the anchoring suture was cut and the tube removed over the wire. A new sterile tube then was fed over the guide-wire and sutured in place after radiographic confirmation of tube insertion depth.

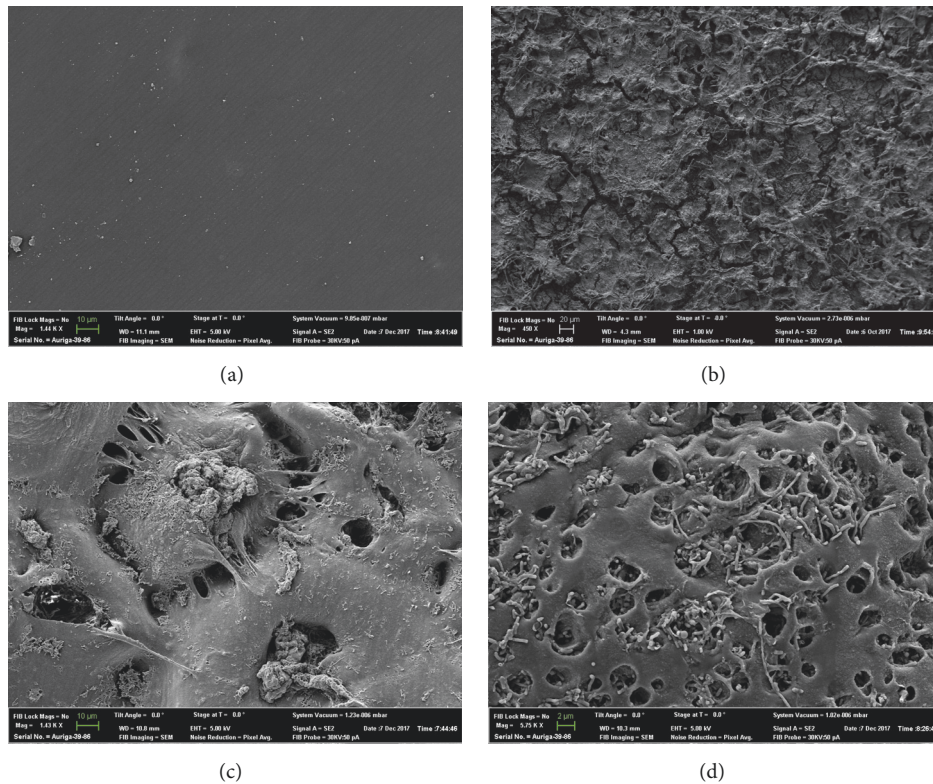
FIGURE 2: Scanning electron microscopy (SEM) images of silicone esophagostomy tubes. (a) The luminal surface of a reference tube. The surface is mostly regular with mild imperfections. The scale bar is equal to  $10\ \mu\text{m}$  and the original magnification is 1.44K. Photo credit: John Dunlap. (b) Thick biofilm with crevices covering the luminal surface of a tube exposed for 77 days in a cat (case 1). Dense mats of fungal mycelia are visible. The scale bar is equal to  $20\ \mu\text{m}$  and the original magnification is 450x. Photo credit: John Dunlap. (c) Biofilm and multiple large pores in the luminal wall of the intraesophageal portion of a tube exposed for 246 days in a dog (case 2). The scale bar is equal to  $10\ \mu\text{m}$  and the original magnification is 1.43K. Photo credit: John Dunlap. (d) Mixed biofilm with bacteria and yeast, as well as a multitude of pores, in the luminal wall of the extraesophageal portion of a tube exposed for 246 days in a dog (case 2). The scale bar is equal to  $2\ \mu\text{m}$  and the original magnification is 5.75K. Photo credit: John Dunlap.

The stoma site was malodorous and exudative. The portion of the tube outside of the body had a diffuse brown discoloration. After tube removal, dark luminal discoloration was identified extending 1.5 cm beyond the insertion site. The external surface of the portion of the tube withdrawn from the esophagus also was diffusely covered with a white exudate and smelled of yeast. Separate samples, thus, were collected from the luminal and extraluminal portions of the tube. Growth from the luminal surface of the tube was flaky and easy to remove from the tube surface. Light microscopy findings were consistent with yeast. *Penicillium* sp., *Candida* sp. (not *C. albicans*), and a *Trichosporon*-like yeast were identified on fungal culture. Growth on the extraluminal aspect of the tube was more adhered. Culture was consistent with *Candida* sp. Scanning electron microscopy findings included a thick biofilm and numerous, variably sized pores within the tube wall, consistent with tube degradation (Figures 2(c) and 2(d)). Stoma-site cellulitis resolved after tube exchange.

Although marked tube colonization was identified in all three E-tubes analyzed in this report, SEM changes consistent with tube deterioration only were noted in one silicone E-tube. The severity of biofilm accumulation prevented accurate structural assessment of the other silicone tube, while the analyzed polyurethane tube had no signs of tube deterioration on SEM analysis. The ideal tube for long-term enteral management is unknown. While mechanical wear will degrade both silicone and polyurethane tubes over time [6, 7], silicone tubes had a greater proportion of intraluminal colonization and altered tube integrity compared to polyurethane tubes in one prospective, randomized-controlled study in people [4]. Conversely, as noted above, some fungi produce hydrolytic enzymes that degrade polyurethane. Additionally, it is important to recognize that certain types of bacteria can metabolize tube components and also play a role in tube degeneration [3, 5]. Given the small number of tubes analyzed, future research is needed to determine if polyurethane tubes are less susceptible to fungal colonization and more resistant to fungal and bacterial degradation or if durability is independent of colonization [6].

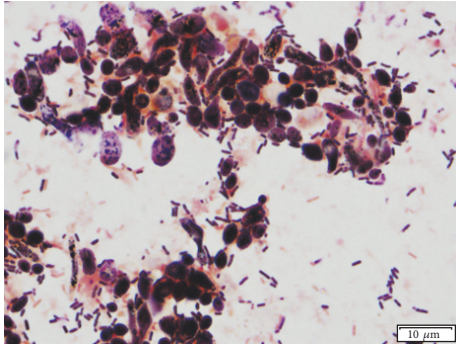
Diffuse whitish colored growth covered the majority of the luminal surface of the portion of the tube that had been outside the body. Lighter growth was noted on the luminal surface of the section of the tube that had been intraesophageal. Small, round to ovoid budding yeast with occasional pseudohyphae were observed by light microscopy (Figure 3). *Candida albicans* was identified on fungal culture. A thick biofilm of bacteria and yeast was evident on SEM, but the visible areas of the luminal E-tube surface appeared smooth; pores and crevices were not noted (Figure 4).

FIGURE 3: 1000x magnification of mixed bacteria and budding yeast like cells on Gram stain from a dog (case 3). Photo credit: Bente Flatland.

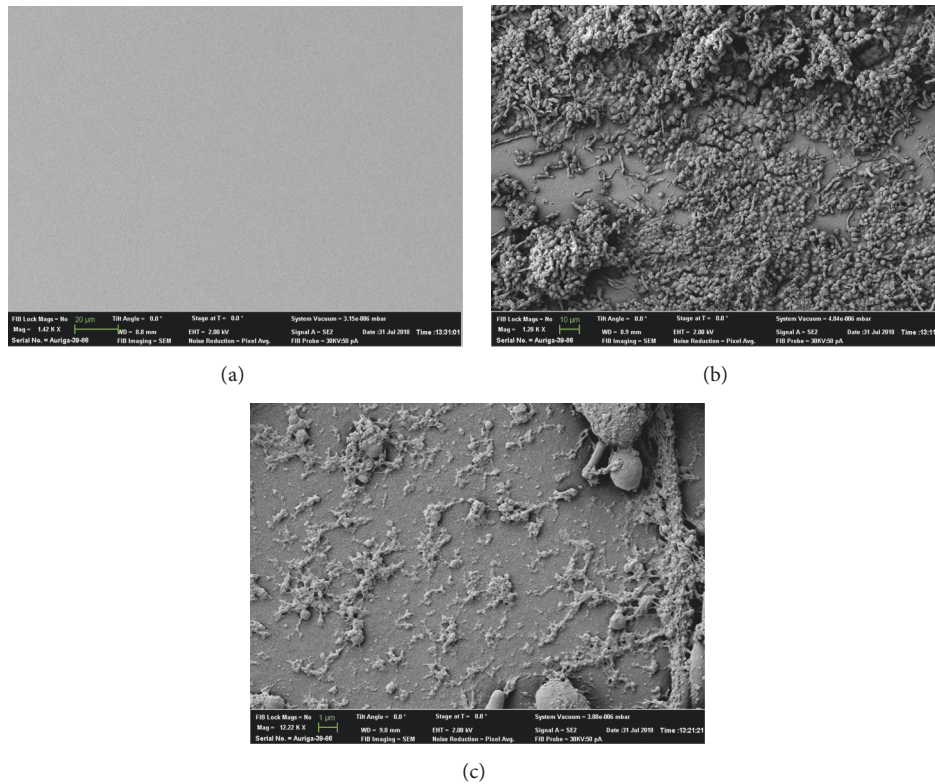
FIGURE 4: Scanning electron microscopy (SEM) images of polyurethane esophagostomy tubes. (a) The luminal surface of an unused polyurethane tube. The scale bar is equal to  $20\ \mu\text{m}$  and the original magnification is 1.42K. Photo credit: John Dunlap. (b) Thick bacterial and yeast-containing biofilm on the luminal surface of a tube exposed for 204 days in a dog (case 3). The visible tube surface has no evidence of pores or cracks. The scale bar is equal to  $10\ \mu\text{m}$  and the original magnification is 1.28K. Photo credit: John Dunlap. (c) Thin biofilm on the smooth luminal surface of a tube exposed for 204 days in a dog (case 3). The scale bar is equal to  $1\ \mu\text{m}$  and the original magnification is 12.22K. Photo credit: John Dunlap.
