## Case Report

# An Unconcealed Reservoir: Case Report of Erosion of Inflatable Penile Implant Reservoir through the Anus

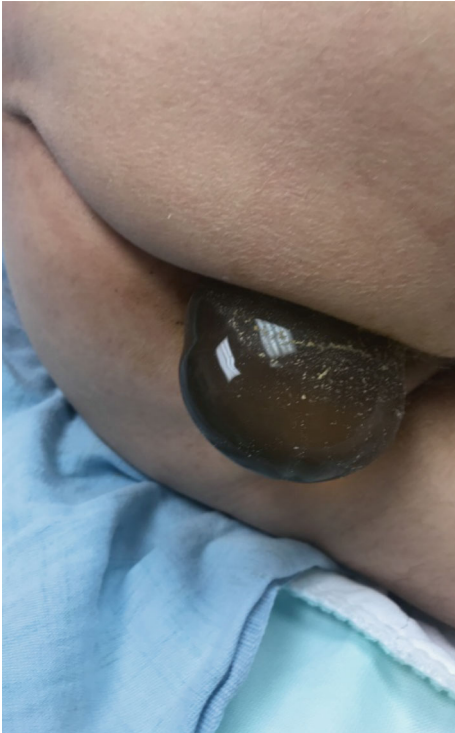
FIGURE 1: Posterior view of reservoir protrusion through the anus.

followed by the feeling of something protruding from his anus. The protrusion was observed to be the reservoir for his IPP (Figures 1 and 2).

He was initially treated with intravenous antibiotics and scheduled for surgery the next day. His IPP was found to still be functional before surgery (Figure 3). During surgery, urology removed the IPP and colorectal surgery performed a diagnostic laparoscopy that did not identify an intraperitoneal

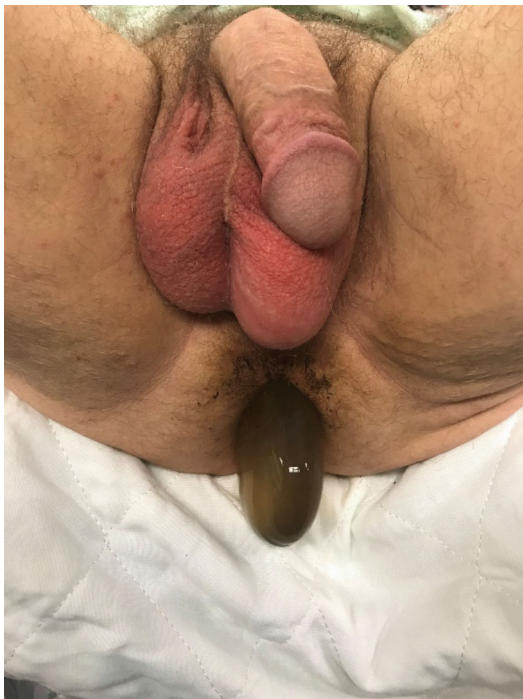
FIGURE 2: Inferior view of reservoir protrusion through the anus.

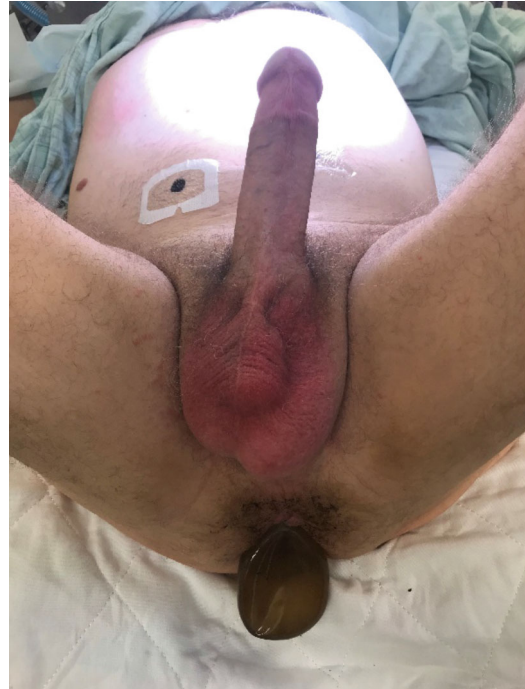
FIGURE 3: Protrusion of a deflated reservoir through the anus demonstrating maintained function of implant device.
